Crescent Machine Company Jointer manufactured about 1918

by Scott Crosby

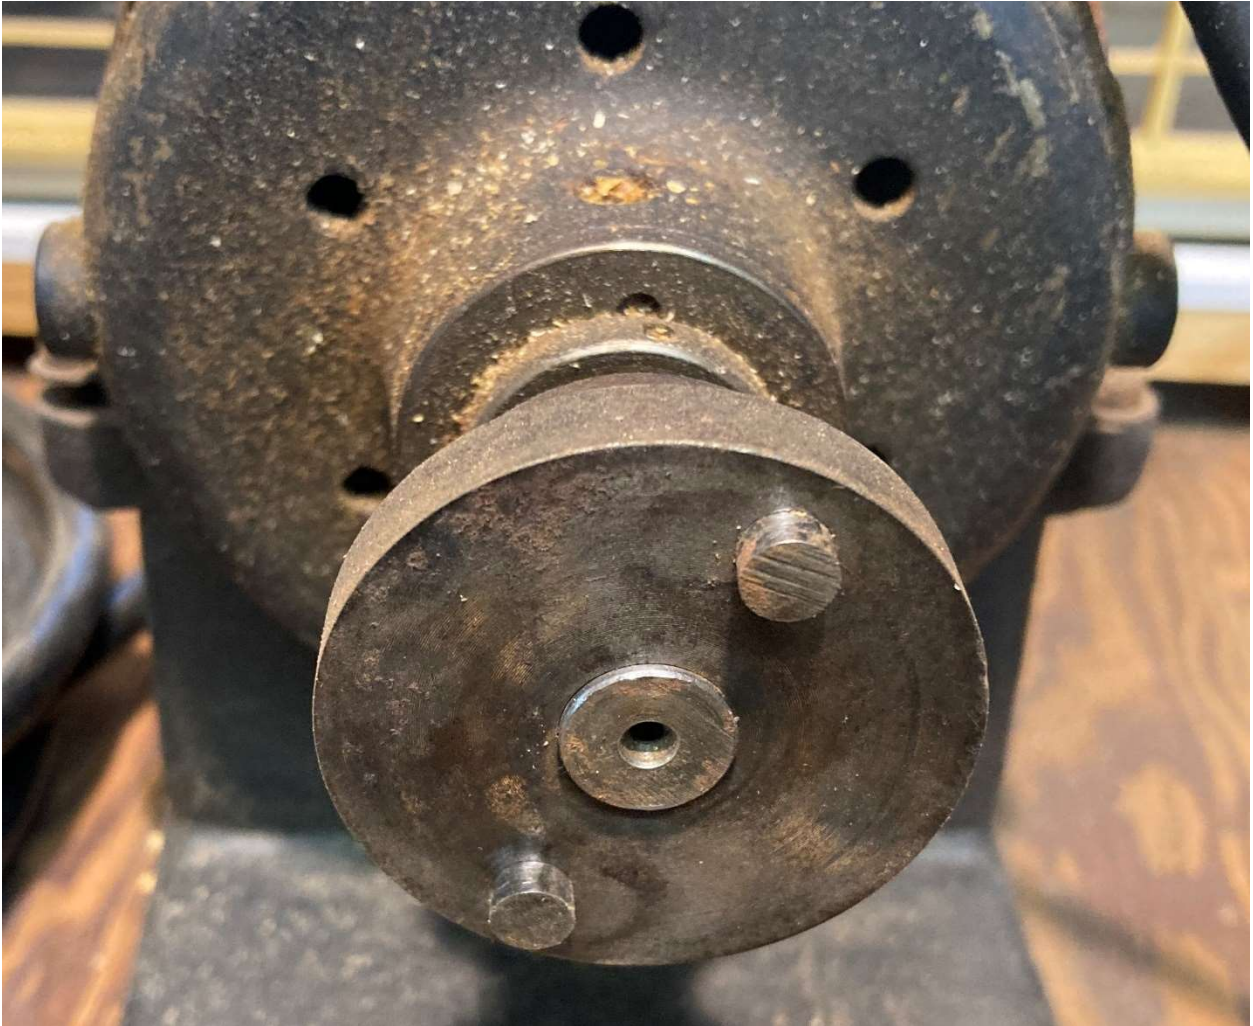
A hub with two studs is attached to the motor's shaft. A similar hub is attached to the barrel's shaft on the jointer.

At the junction of the two hubs is a rubber / plastic disc, which acts as a shock absorber to allow the whole assembly to endure the sudden changes of speed which can be expected in normal use.

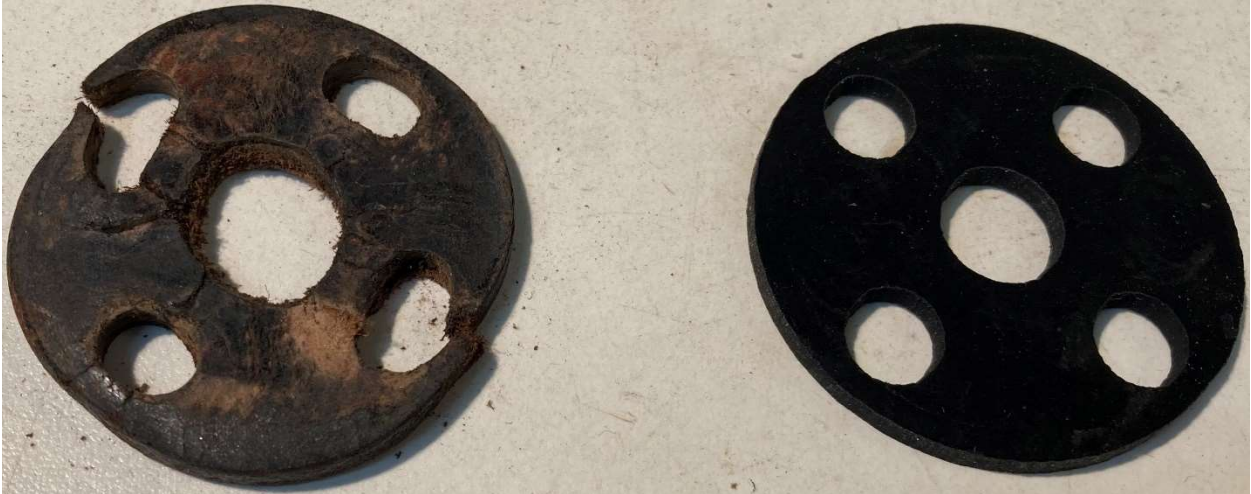
The old and new shock-absorbers for the motor-jointer connection.

The old rubber disk was naturally quite worn, so I had a Neoprene disk made up with the same dimensions by another local company, **Dixie Rubber & Plastics**, of Greenville, SC. Given the costs, it made more sense to have two produced, to keep a spare on hand.

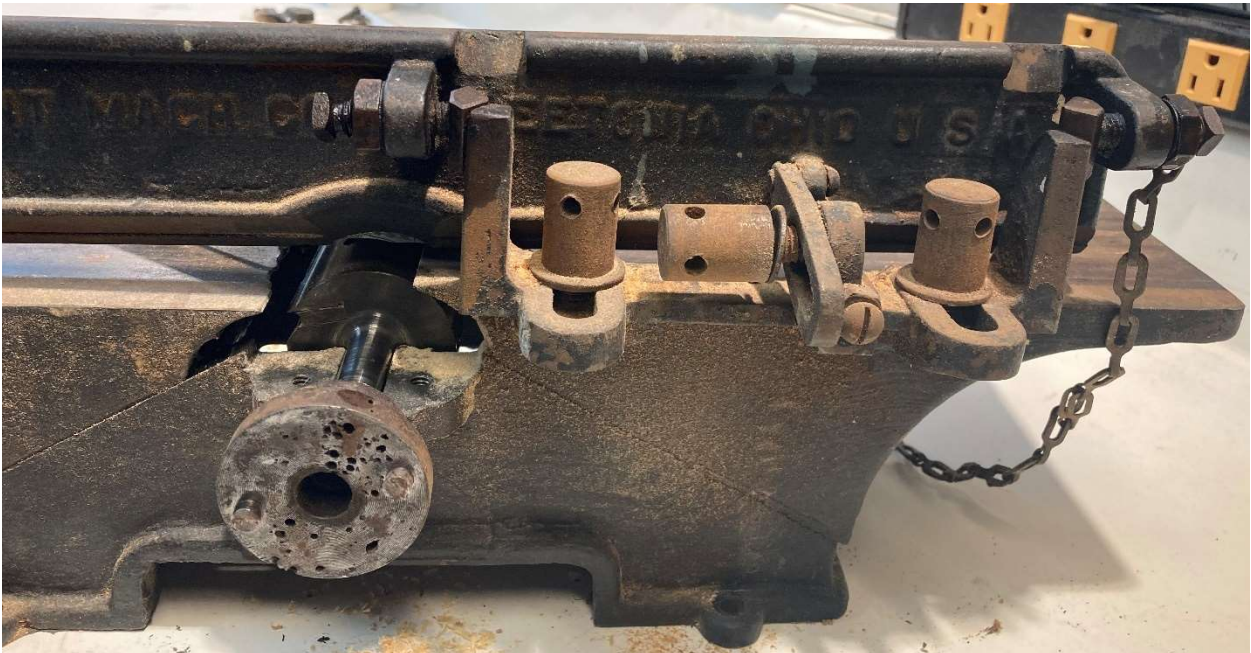
This photo shows the jointer's motor-connection disk, with its two studs.
It also shows the arrangement of parts, which would prove invaluable in later reassembly

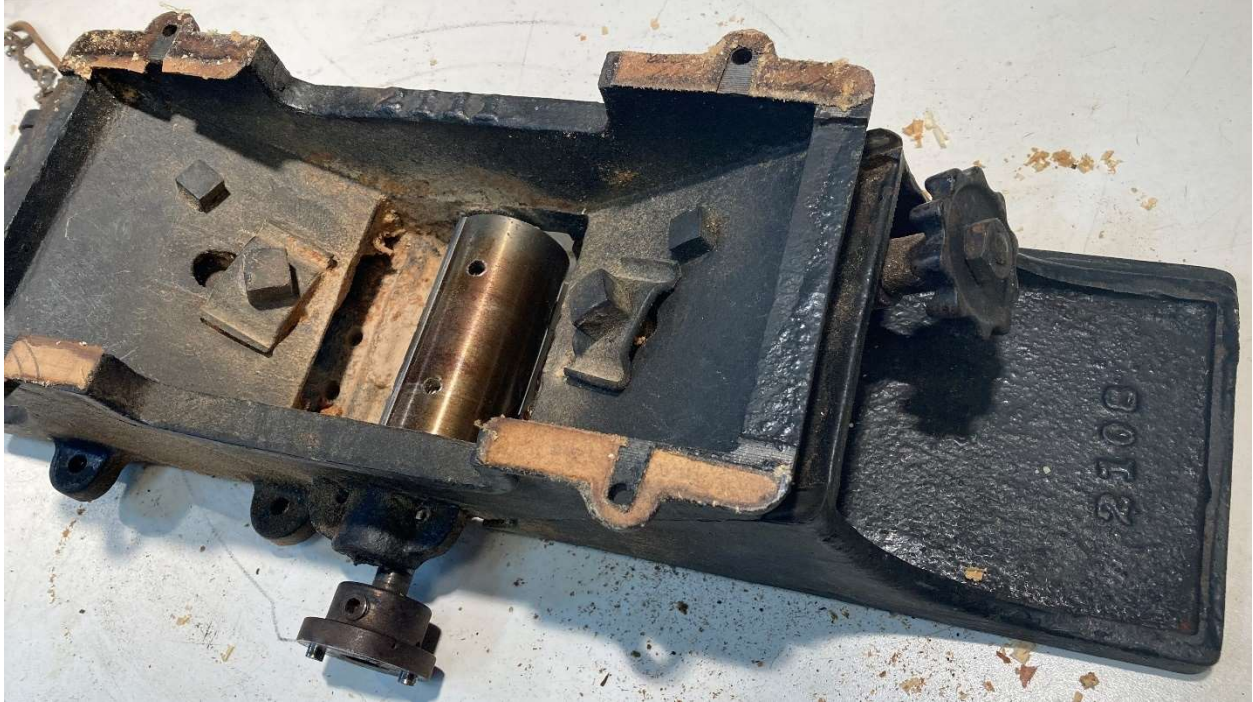
The underside of the jointer, after removal from its baseplate.

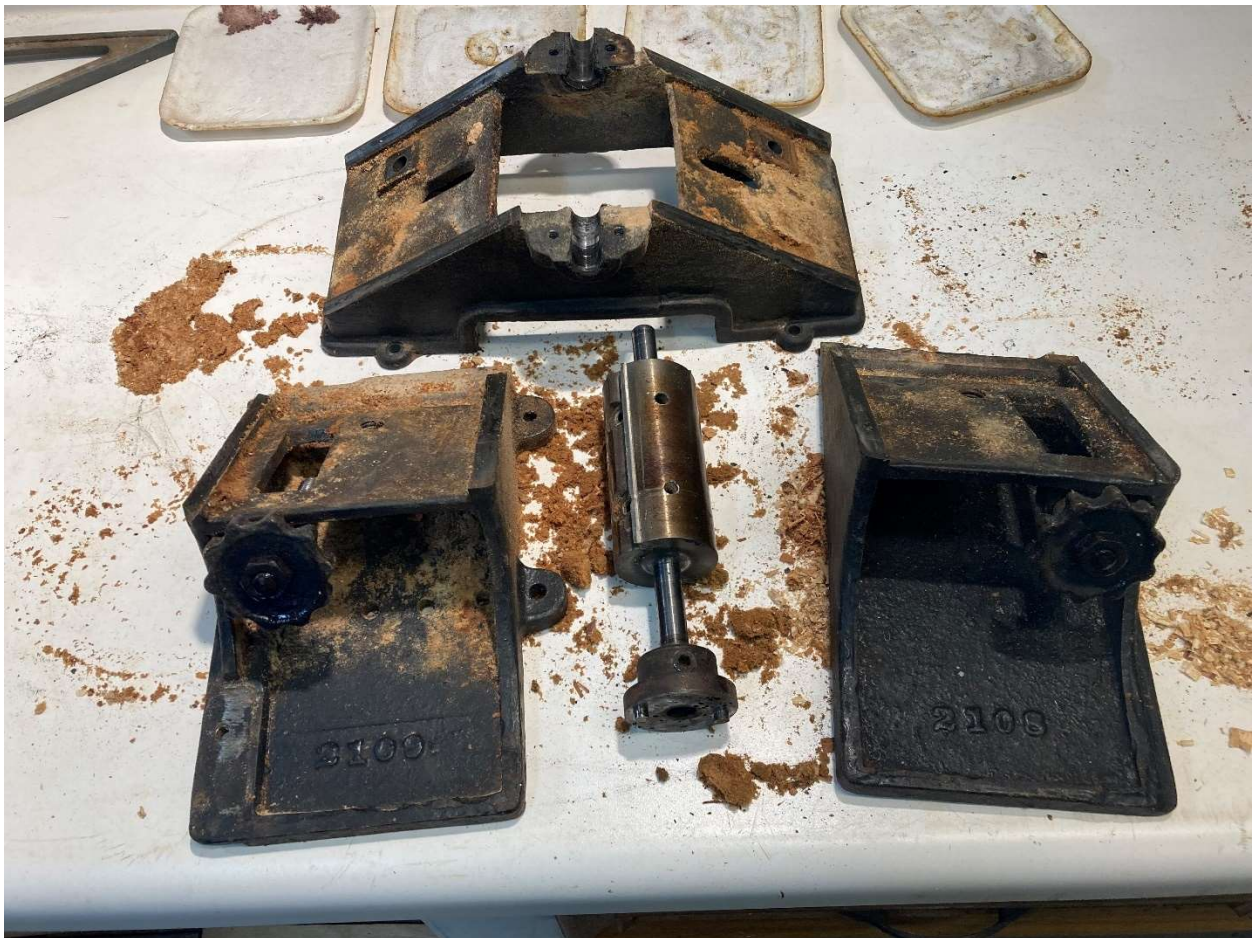
Disassembled except for the two slides, with most residue removed

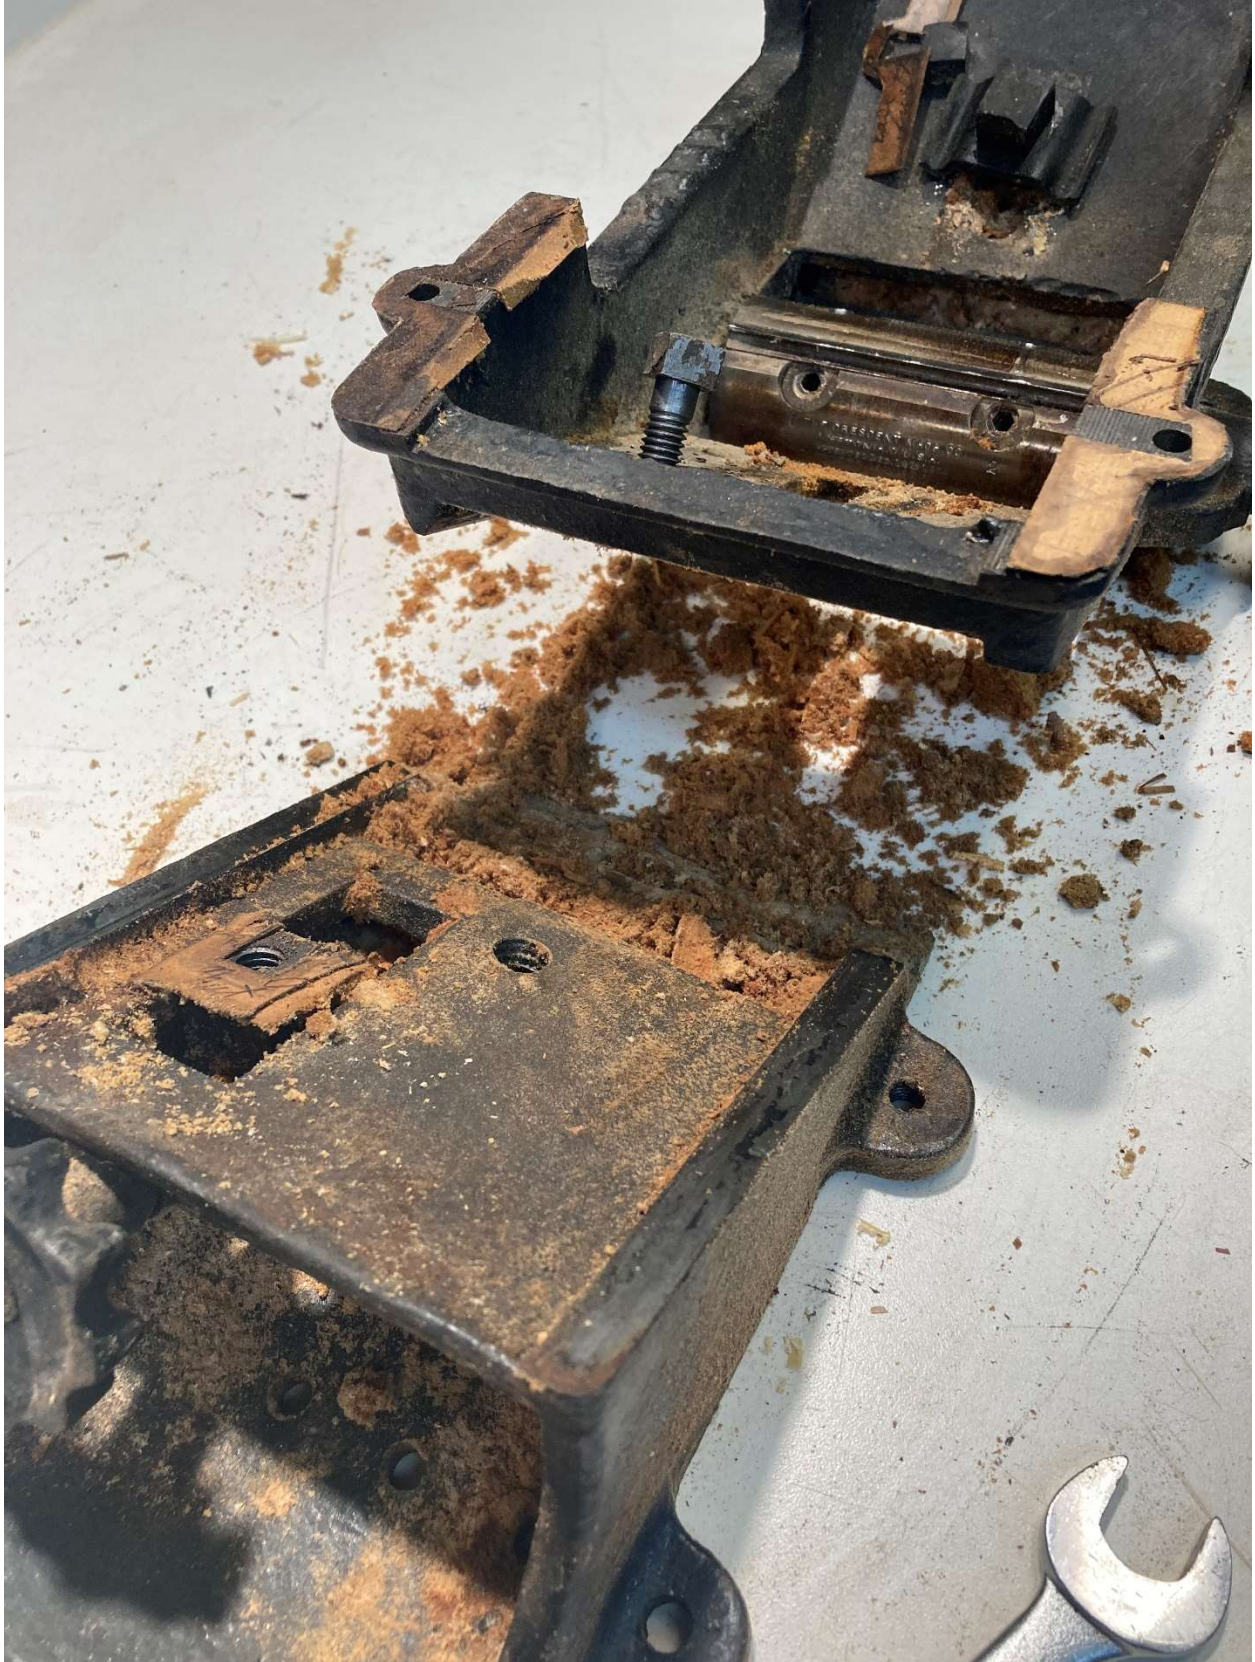
Decades of residue, after full disassembly and prior to a full cleaning.

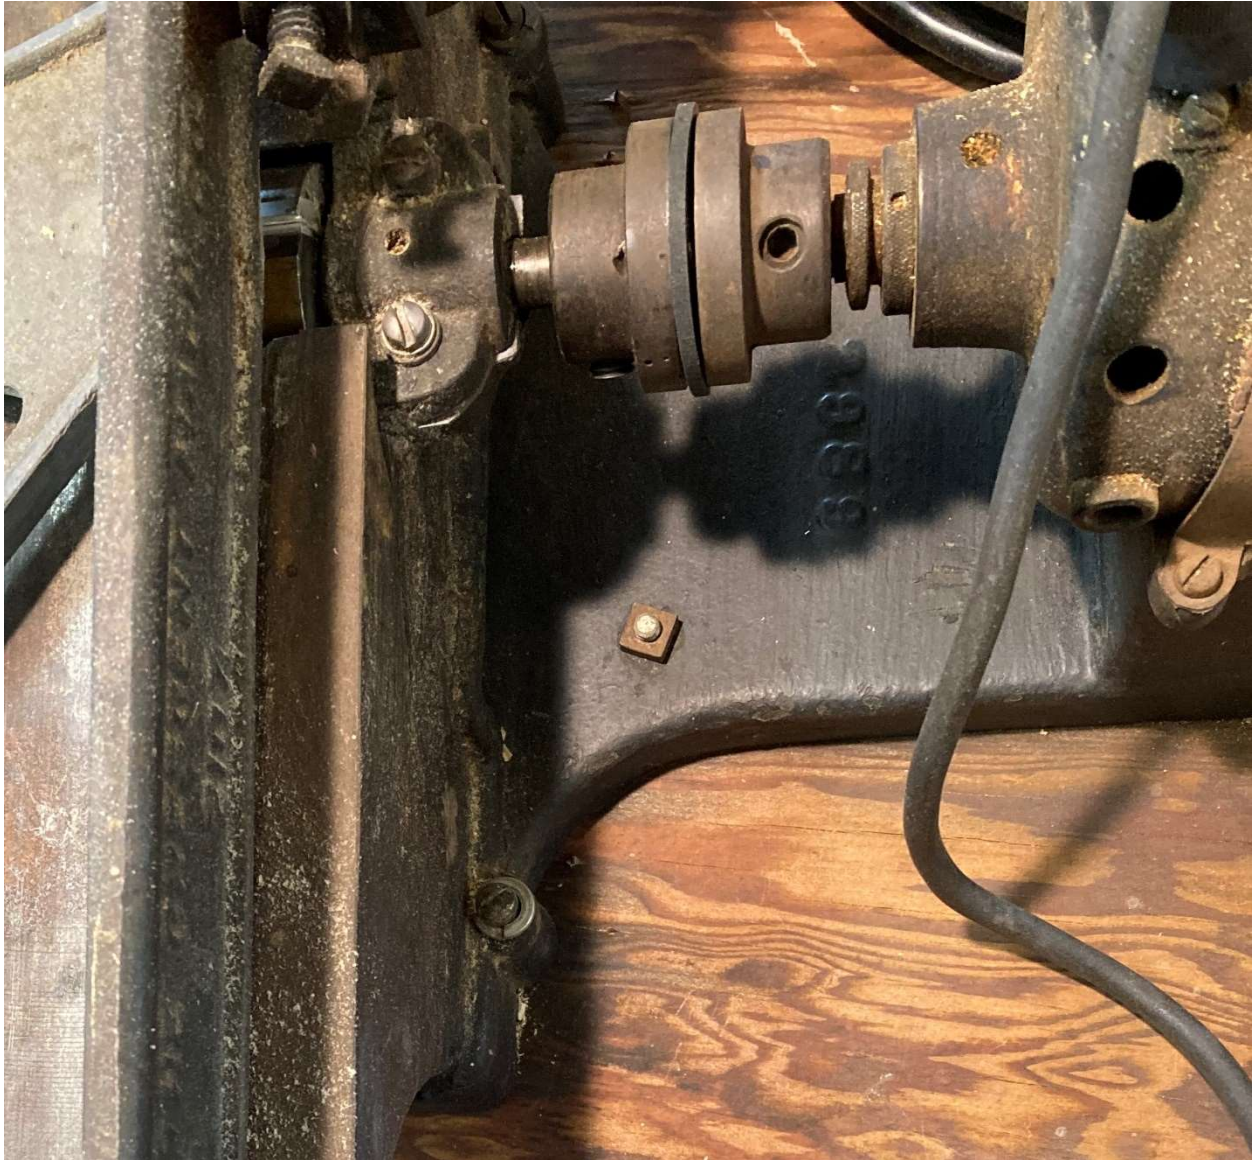
Fully cleaned up and reassembled, with the new shock-absorbing grommet in place.

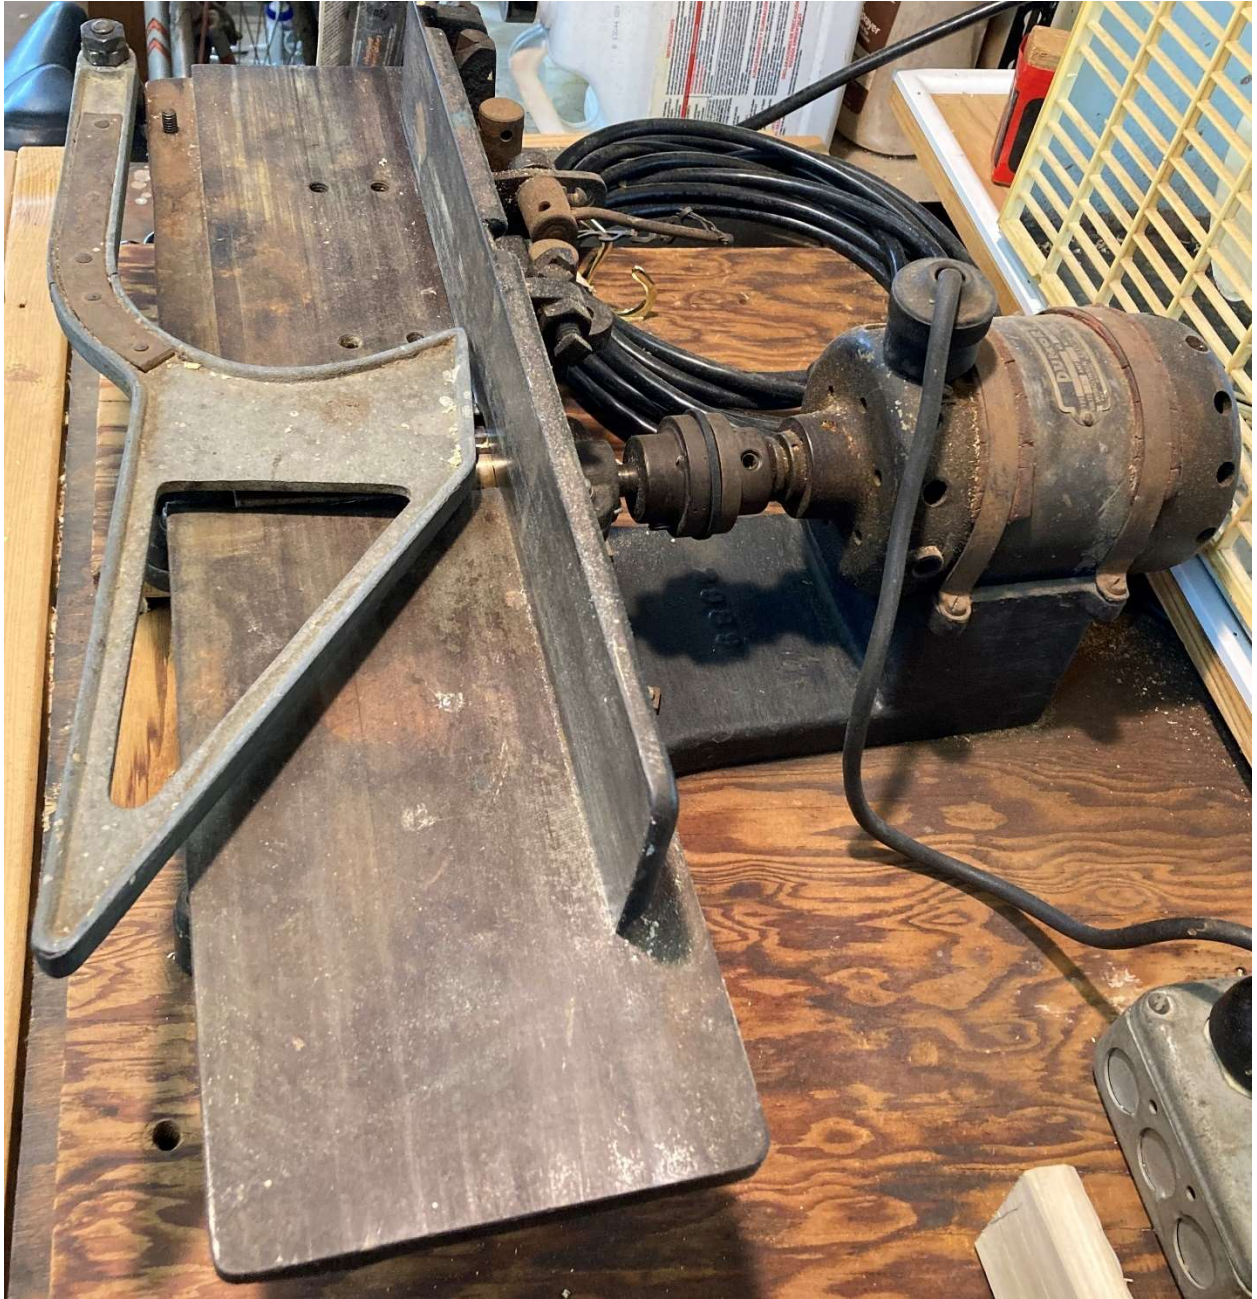
Ready-to-run!
